DSTO-TR-0229

Investigation of Fatigue Cracking
on LAU-7/A Launcher Housing

D.S. Saunders, M.G. Stimson,
R. Bailey and E. Kowal

**Airframes and Engines Division
Aeronautical and Maritime Research Laboratory**

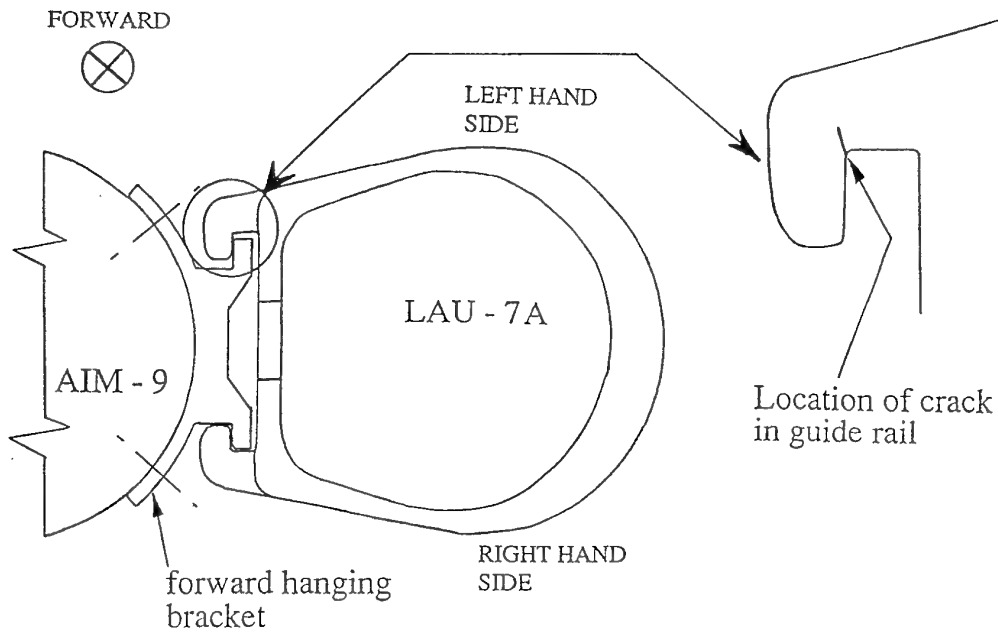
The location of the fatigue crack is shown in Figure 4 and a typical fracture is shown in the inset figure. Left and right-hand sides of the launchers are also defined in Figure 4. At overload failure, when the fatigue cracks have attained critical length, the fatigue cracks are generally of high aspect ratio typically 40 mm along the length of the guide rail and 1 to 3 mm deep. The shallow nature of the cracks creates some considerable difficulty in the inspection of the guide rails. In conjunction with NDISL², No. 481 Wing has developed a new NDI technique which, within the limitations discussed in Section 5.6 of this report, appears satisfactory for the inspection of guide rails. The previous standard technique and the inexperience of operators led to some inaccurate reporting of crack lengths and, possibly, over-estimation of the numbers of launcher guide rails which had cracked in service.

Figure 4. The location of cracking in the LAU-7/A launcher guide rail and typical fatigue crack (inset).

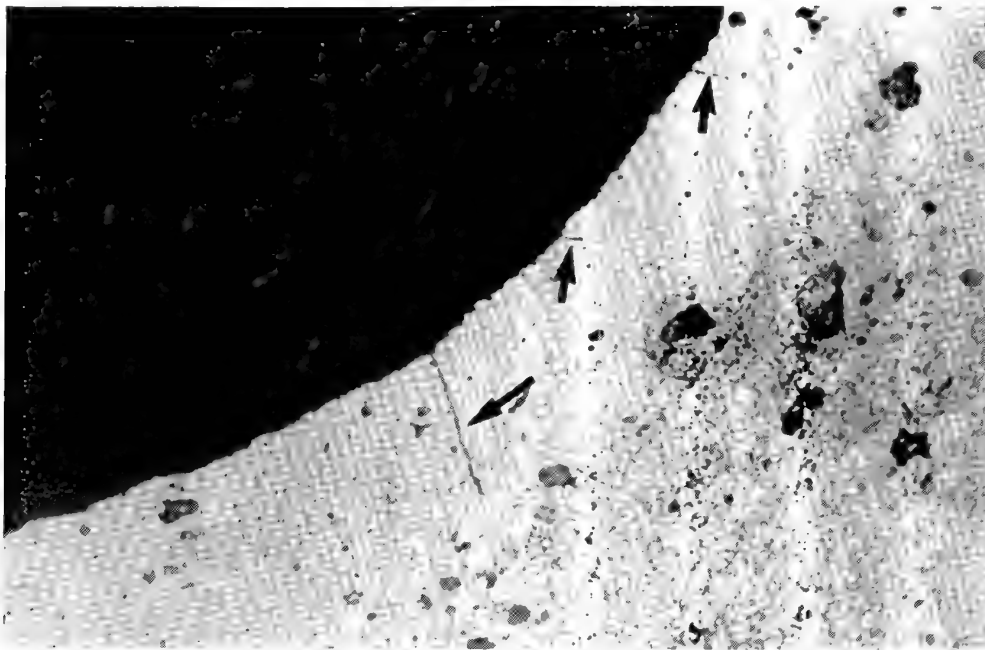
From a metallographic examination of a launcher failed in service, [2] it was apparent that cracking initiated as a result of the stress raising effect of the sharp radius under the lip of the guide rail. This is shown in Figure 5 (after [2]), where it can be seen that initiation of cracking is at a number of sites. The presence of small, intermetallic particles near the surface possibly aided the initiation of cracking. The preliminary scanning electron microscopy has shown that sub-critical crack extension occurred by fatigue. Within this region there was evidence of frequent over loads (causing patches of dimpled rupture) and regions of striation crack growth typical of fatigue. Final fracture by microvoid coalescence (overload) occurred when the crack had grown to a depth of 1 to 3mm, see Figure 6.

Figure 5. *Optical micrograph of the region of cracking in the guide rail of LAU-7/A launcher number 0159, from [2]. 6X*

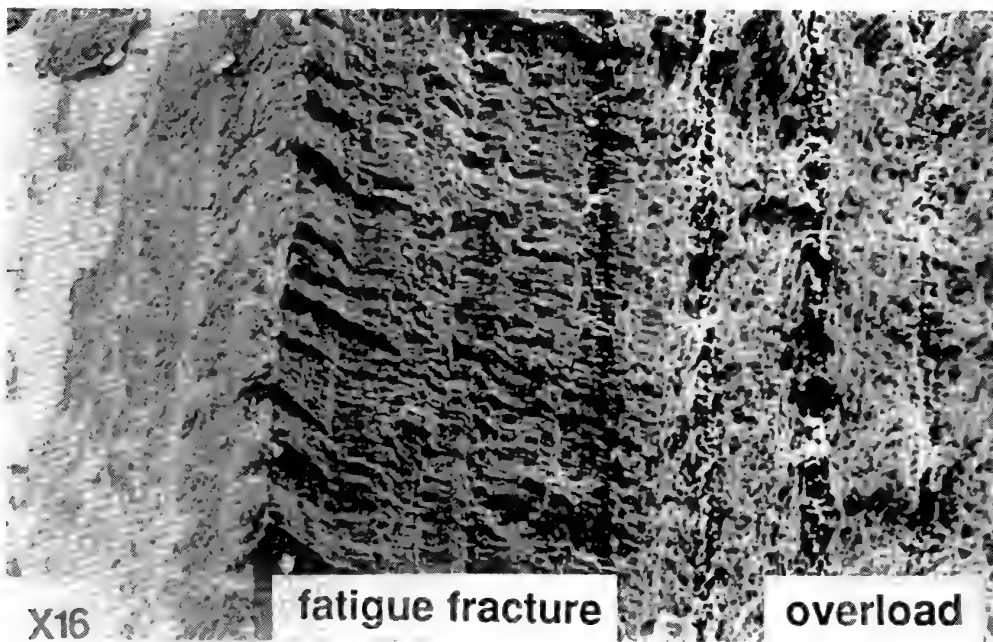
Figure 6. *Scanning electron micrograph of the fracture surface from the guide rail of LAU-7/A launcher number 0159, after [2]. 16X*

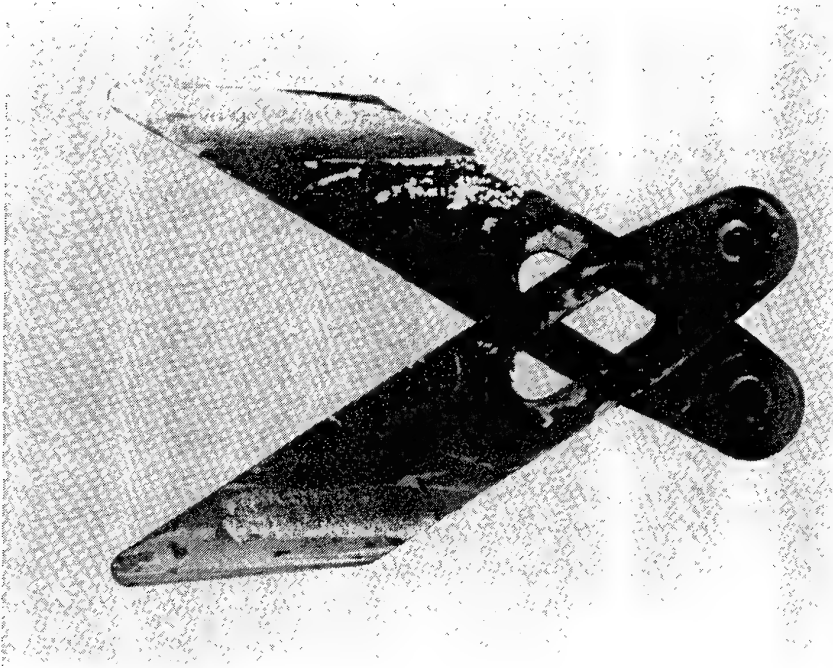
Severe wear to the aft snubbing scissors has been observed, Figure 7, as has the wear to the aft hanging brackets seen in Figure 8. Wear has also typically been reported on the

Figure 7. *Worn scissor blades from the aft snubber mechanism. Scissors were painted black prior to cycling to illustrate the wear which reduces snubbing effectiveness*

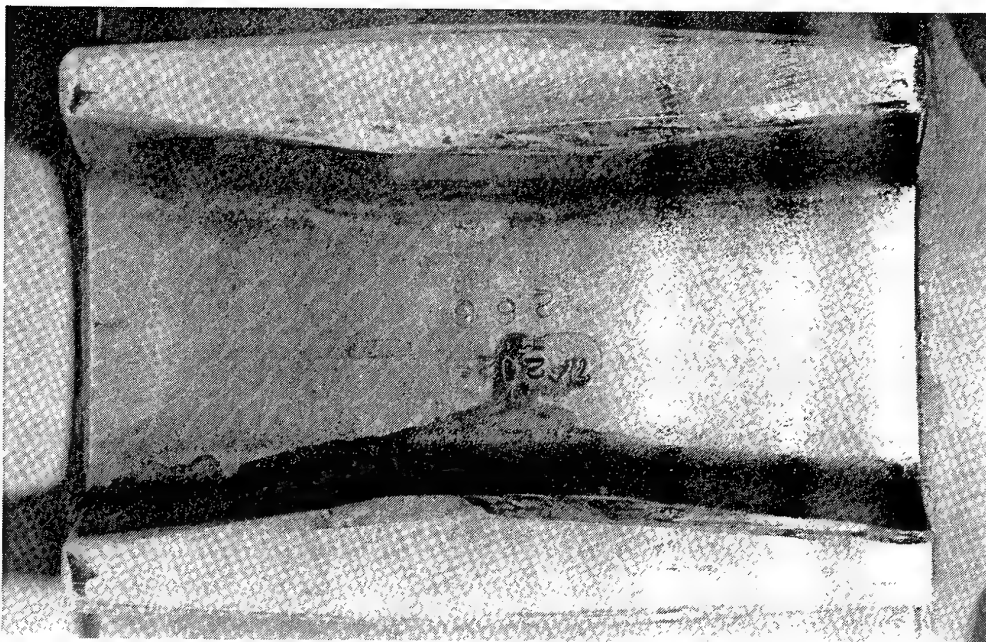
Figure 8. *Wear of the inner corners of the aft hanging bracket corresponding to that of the scissors.*

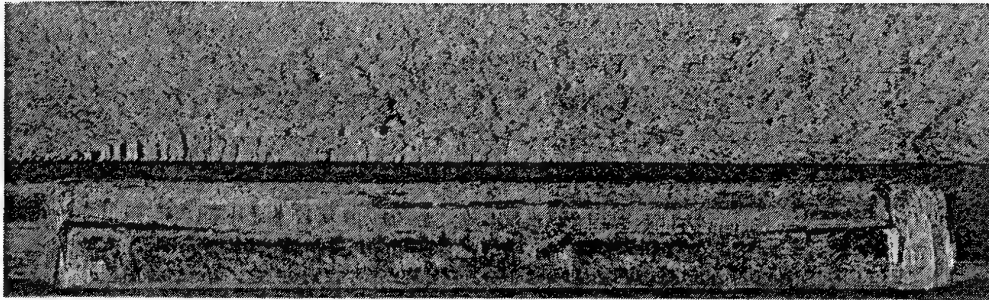
guide rails at the location of the missile forward hanging brackets, Figure 9, and to the missile forward hanging brackets. These types of damage all suggested appreciable movement of the missile during carriage, but there was no evidence to suggest that the cracking in the forward region of the guide rail was initiated by the wear, see also Reference 2. In fact Figures 5 and 9 show that the crack initiation sites are remote from the wear marks produced by the hanging brackets.

Figure 9. *Wear of the inside surface of the rail over the contact zone of the forward hanging bracket. The hills and depressions of the wear marks cause great difficulty for NDI processes. The fatigue crack grown under the test load spectrum is difficult to discern from the overload failure zone.*

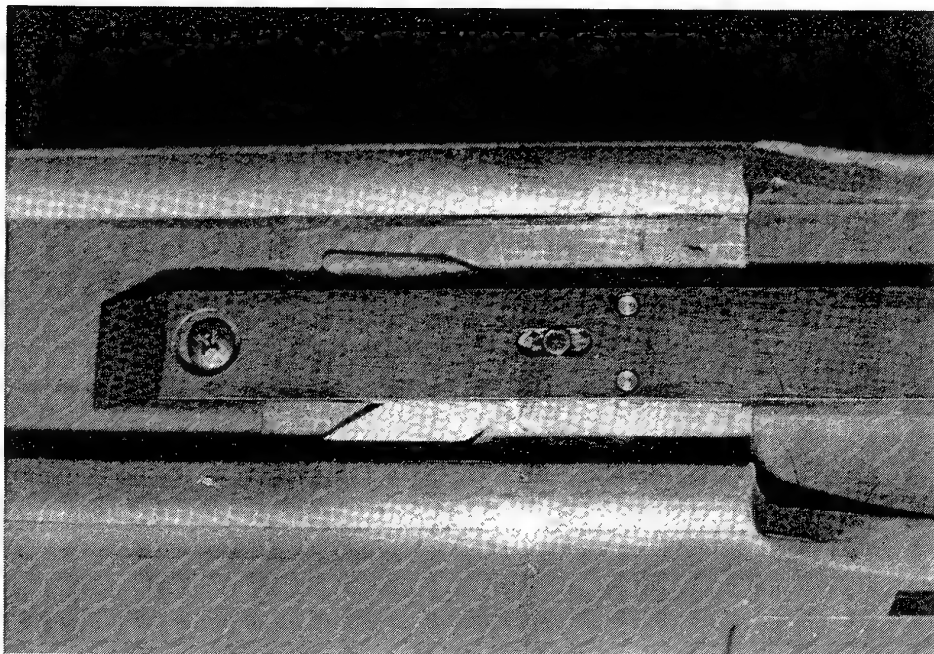
Figure 10. *The RAAF wear plate installed under the aft snubbing mechanism in an attempt to force the missile hanger against the rail and restrict vertical movement.*

In an attempt to overcome the problem of ineffective aft snubbing and presumably decrease load shedding to the region of the forward hanging bracket the RAAF has designed a wearplate which is inserted under the aft snubbers thereby increasing the wedging forces and reducing missile movement, Figure 10. The effect of this plate on the strains at the forward hanger was investigated. Similarly, in an attempt to decrease the loads at the forward hanging bracket, the Canadian Forces have designed sets of teflon cylinders to react aircraft loads directly onto the launcher housing rather than through the guide rails, Figure 11. As an aside in the project this configuration was also investigated in the strain surveys.

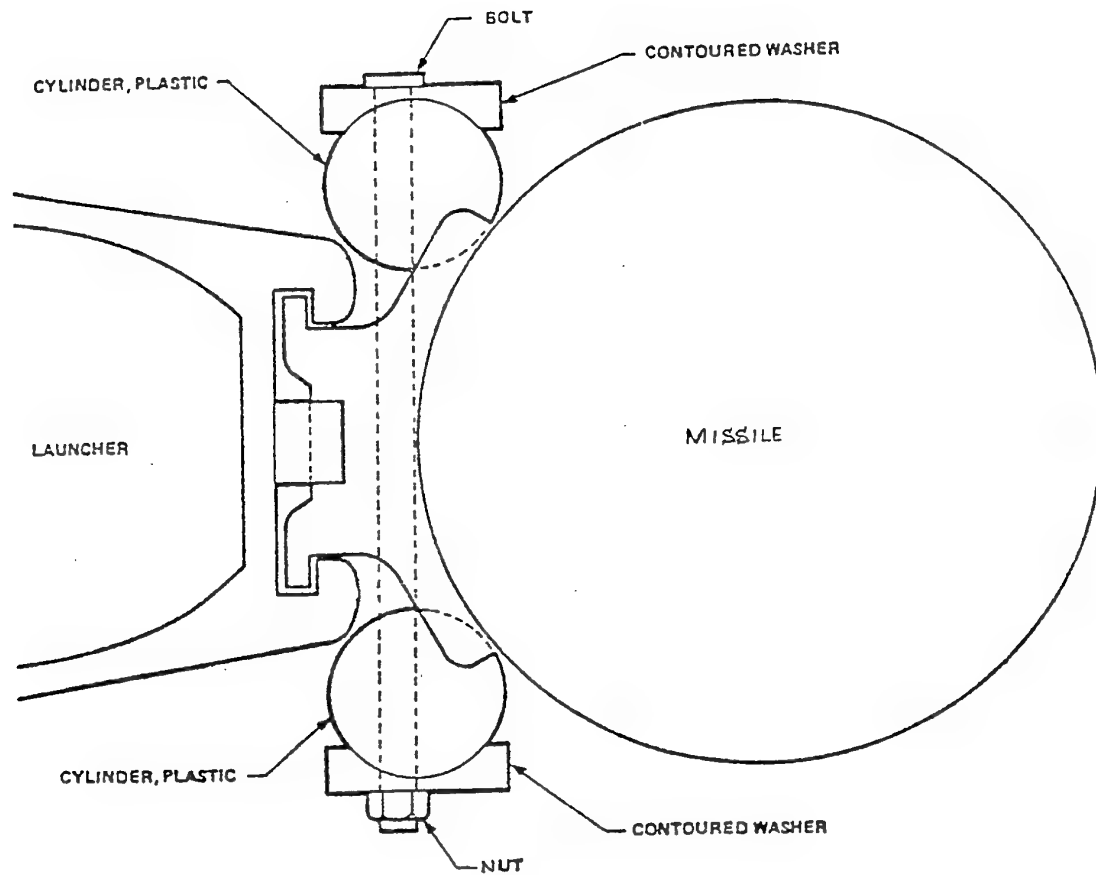
The teflon cylinders introduced by the Canadian Forces were replicated and trialed in just two experiments. The configuration is seen in Figure 11 from [9]. One set of cylinders was adjacent to the forward snubbers and one set attempted to restrict missile vertical movement at the aft snubbers. The recommended torque settings were used, but re-torquing was required after only a few high load cycles as the teflon deformed.

Figure 11. *A cross section of the launcher-missile combination showing the CF design of teflon cylinders to increase snubbing forces. The teflon prevents damage to either part, but soon deforms and loses effectiveness.*

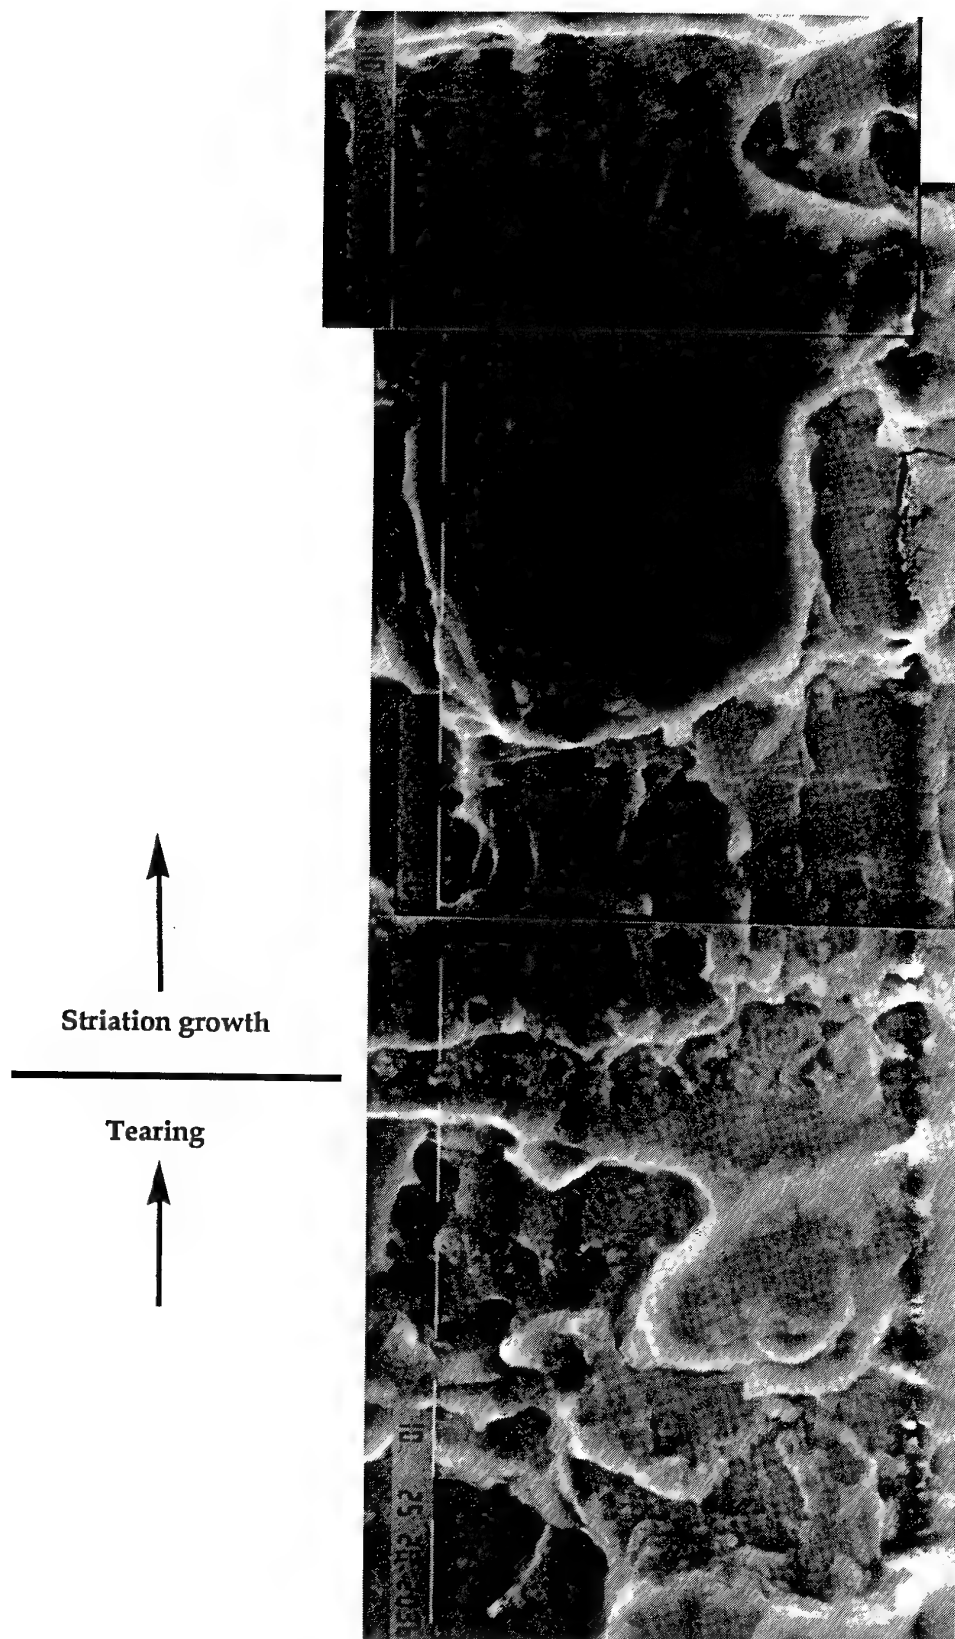
Two fracture surfaces from failed LAU-7/A launcher housings were examined using a scanning electron microscope. The surfaces were taken from launchers 0217 and 0355. The fracture surface from launcher 0217 was of particular interest because this rail failed in 234 hours, see Table 1. This was considered by the RAAF to be an extremely low number of missile carriage hours. Unfortunately, as overload occurred while the missile was being carried, some damage was sustained by the fracture surface with the result that the initiation point was not preserved on the surface.

Figure 16. Fatigue crack growth in the guide rail of launcher NMH 0217 due to service loads. Within the striation bands growth occurs at an average of 900 striations per mm.

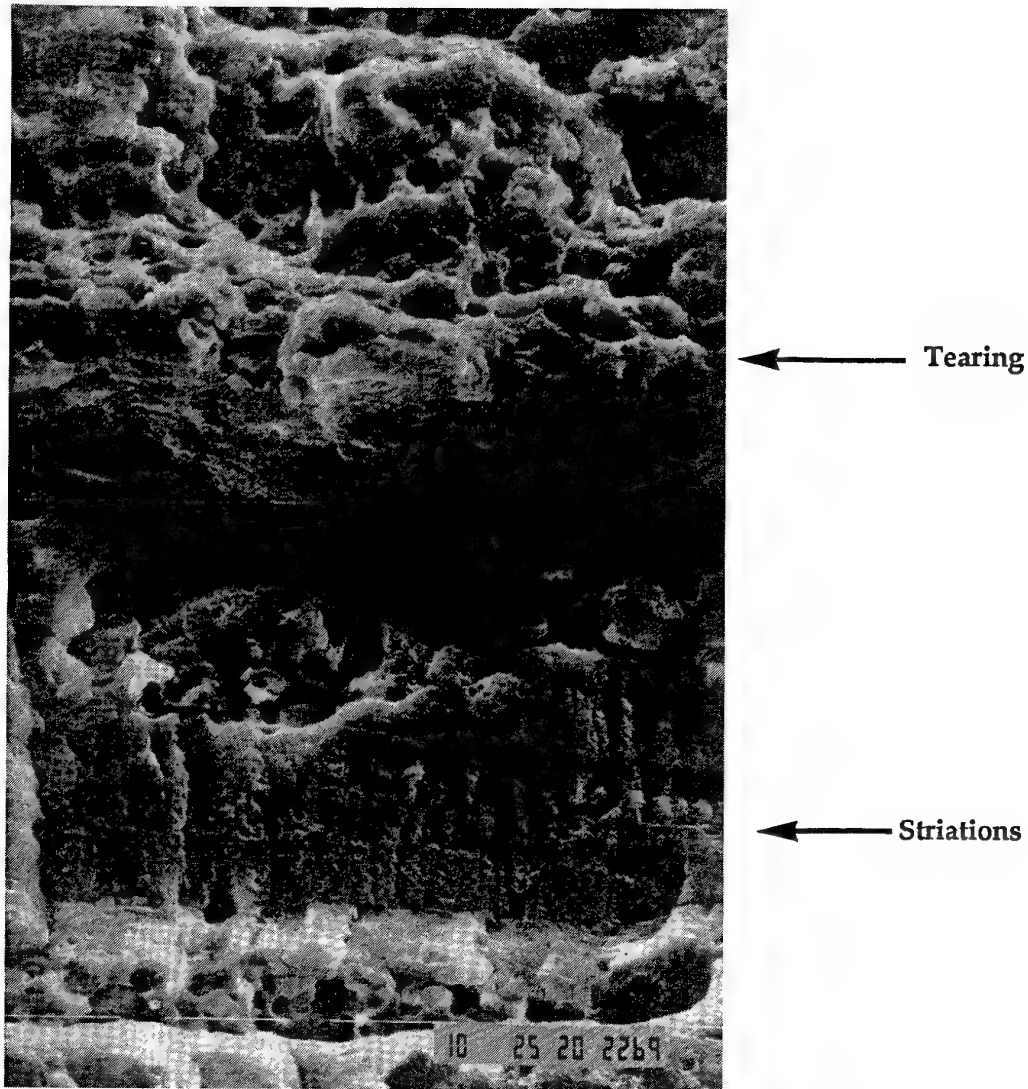
Figure 17. *Another example, from a launcher found overloaded in operational service, of fatigue crack growth interspersed with ductile tearing . This scanning electron micrograph is of launcher S/N 0355.*

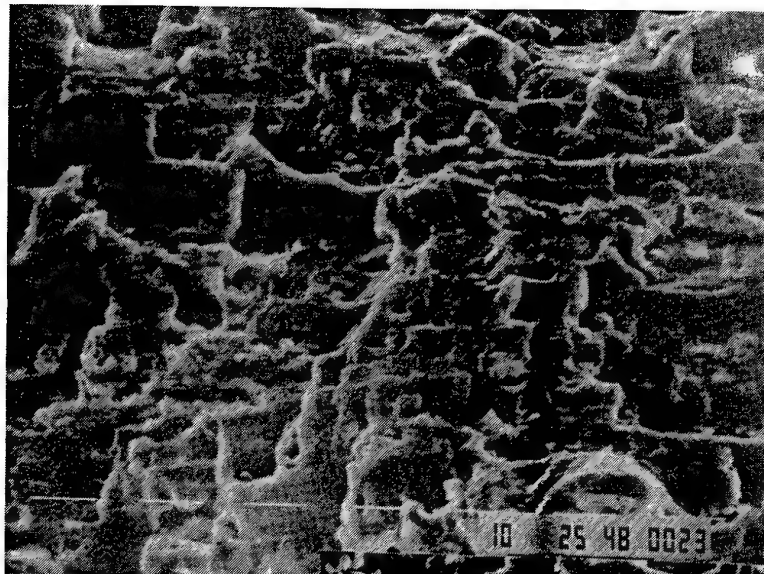
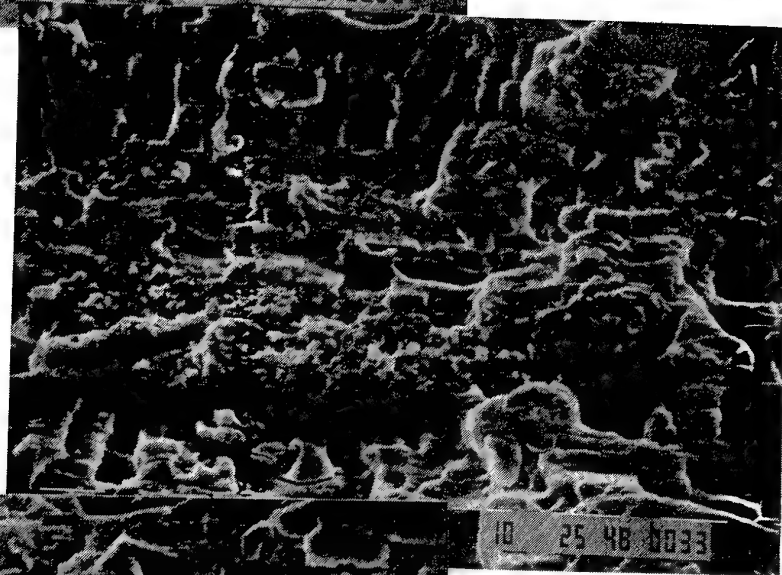
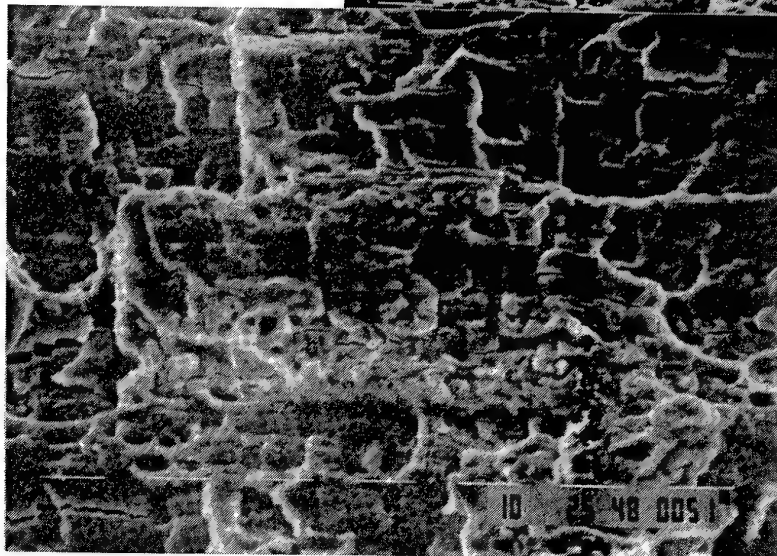
Figure 18. *Fatigue crack growth in guide rails of launcher 71032-012 tested in the laboratory. (a) initial cracking in service, (b) Nz spectrum factored by 3.0, (c) final stages of cracking with spectrum factored by 2.5*

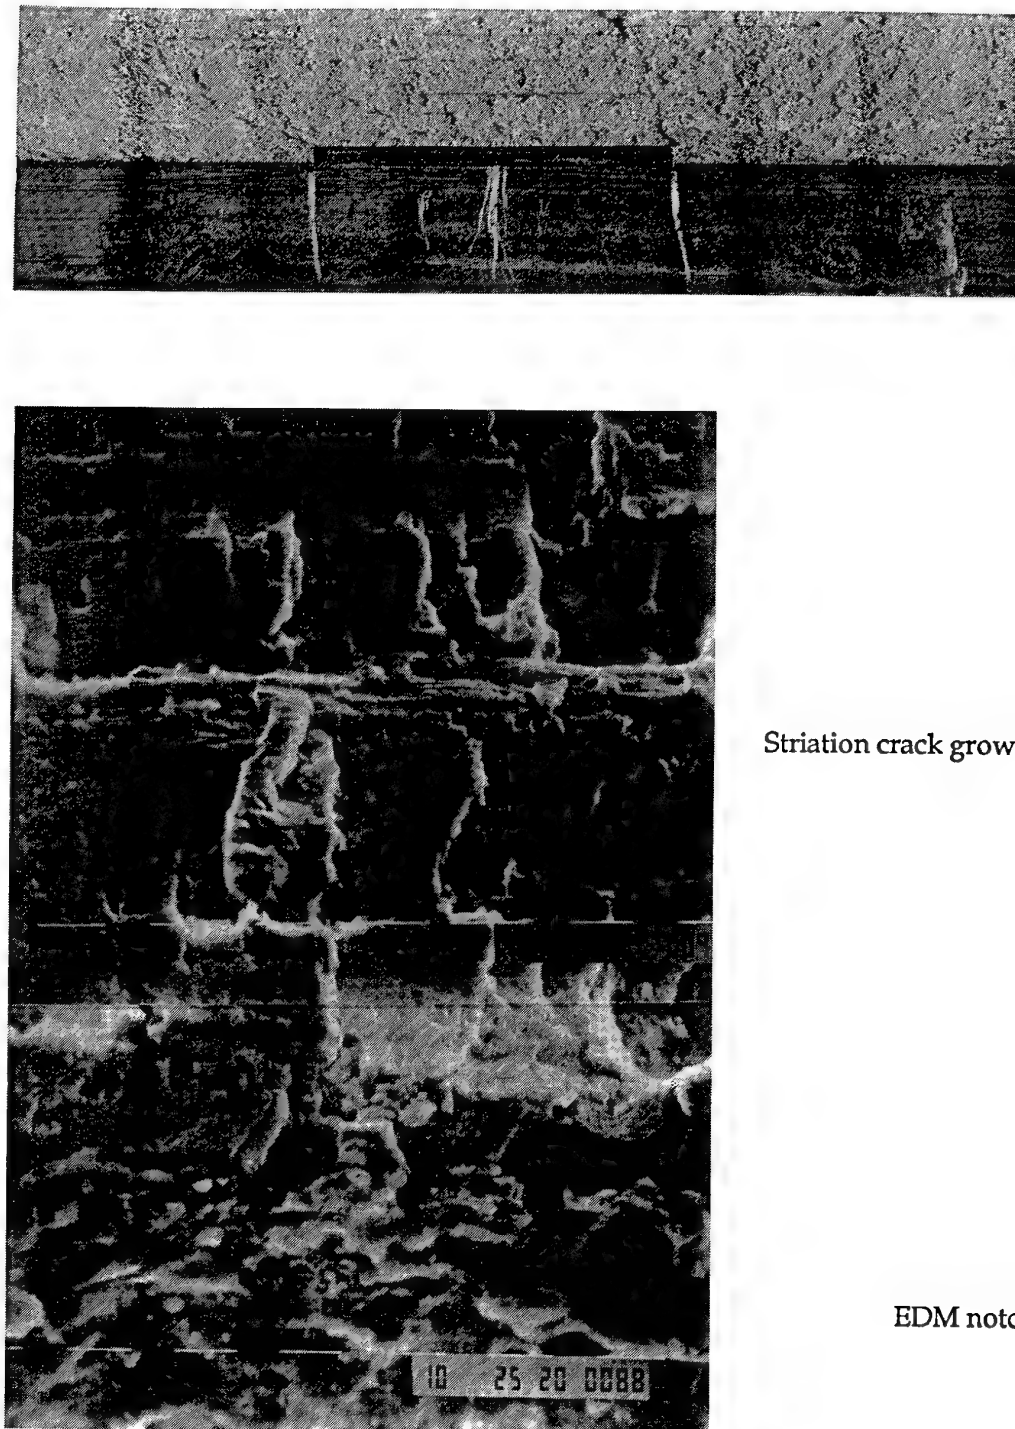
Figure 19. *Fatigue crack growth from an EDM notch in the guide rail (inset) of launcher 0175. The delineation between the melted grains of the notch and the sharp edges of the striation crack growth is difficult to discern.*

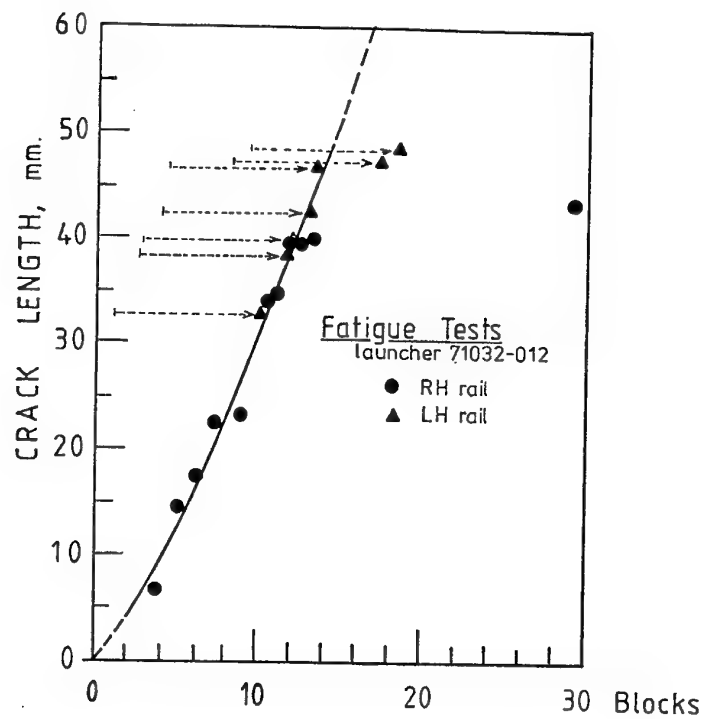
Figure 23. Crack growth in the guide rails of launcher 0148 from laboratory fatigue test.

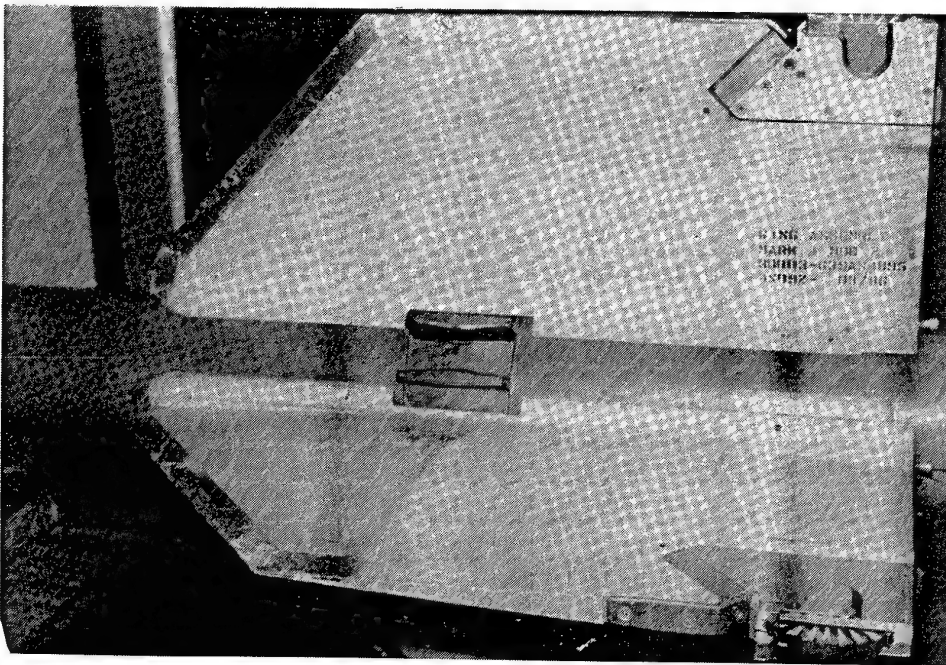
Figure 24. *Dark debris particles deposited on the fin as a result of wear at the aft hanging bracket during fatigue testing.*
